9/1/2021

Re: Tree protection for New Single-Family Home at 16484 South Kennedy Road, Los Gatos, CA, 95030, Parcel 2

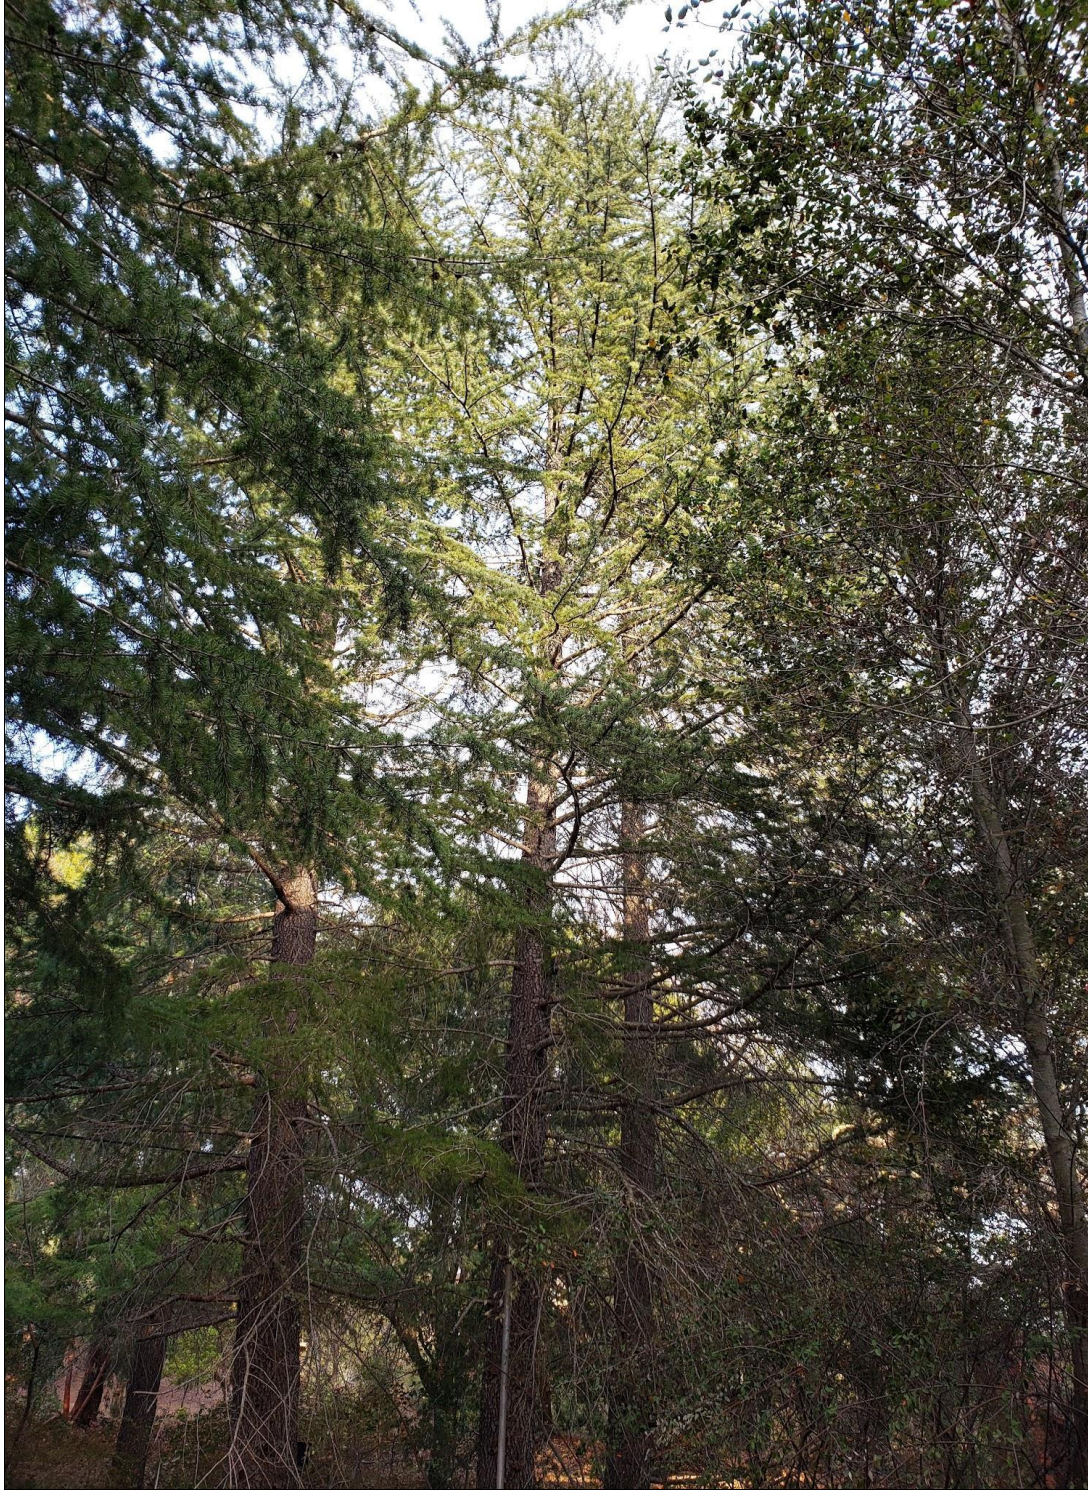
Installation of the proposed water line via trenching is incompatible with Parcel 1 tree #1 and would likely cause major impacts to Parcel 1 trees #7, and moderate impacts to trees #3 and 8.

Grading for and installation of the proposed driveway and associated retaining walls will likely cause moderate impacts to Parcel 1 trees #1-3, 7, and 8, and Parcel 2 tree #23; and minor impacts to Parcel 2 tree #18.

Installation of the northwestern gate post will likely impact Parcel 1 tree #7 to a moderate extent, and Parcel 1 tree #2 to a minor extent.

Image 1: deodar cedars #1-3 (left to right; obstructed; best possible angle)

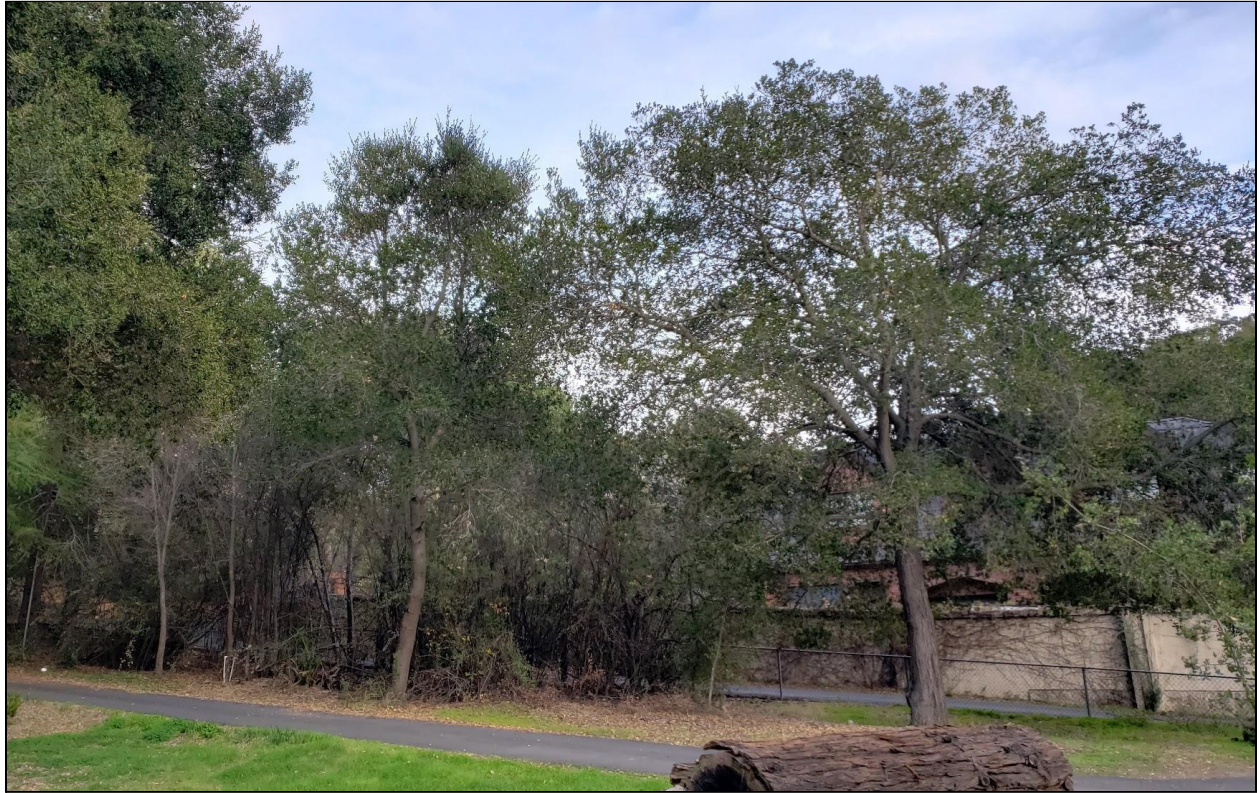
Tree #16 - construction access to the proposed garage lies within this tree's TPZ.

Tree #17 - this tree's trunk lies within the proposed garage footprint.

Tree #17 must be removed for the garage to be constructed.

Tree #16 will likely undergo minor impacts from construction access to the proposed garage.

Image 2: coast live oak grove #4-17 (left to right, some obstructed)

1. Remove trees #17, 26, 27, 30, and 31, upon receipt of a permit from the Town of Los Gatos.
 - a. Retain debris from all coast live oaks and California bays onsite, and preferably other tree species as well. Comply with all other industry best practices for dealing with sudden oak death-infected material.

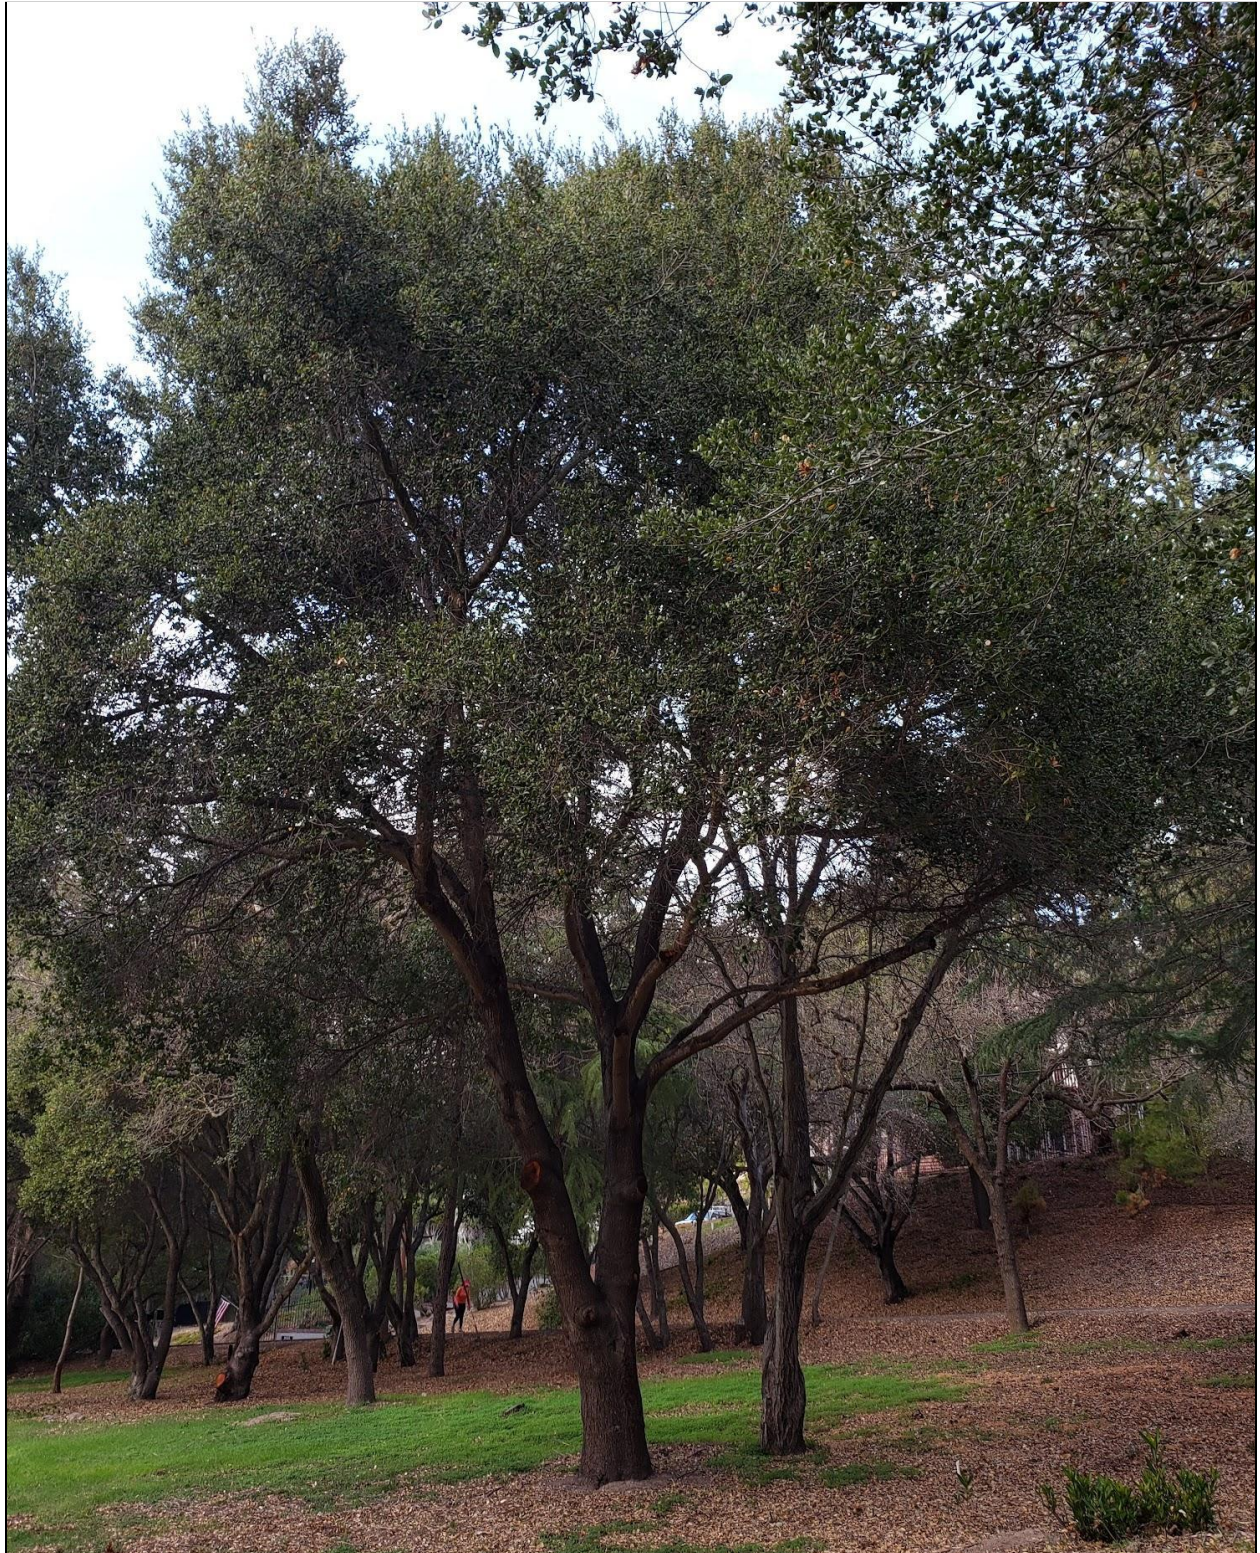
Tree #18 - the proposed retaining wall on the lower (southeast) side of the driveway lies slightly within this tree's TPZ.

Image 3: coast live oaks #18 (left, foreground) and 19 (right, background)

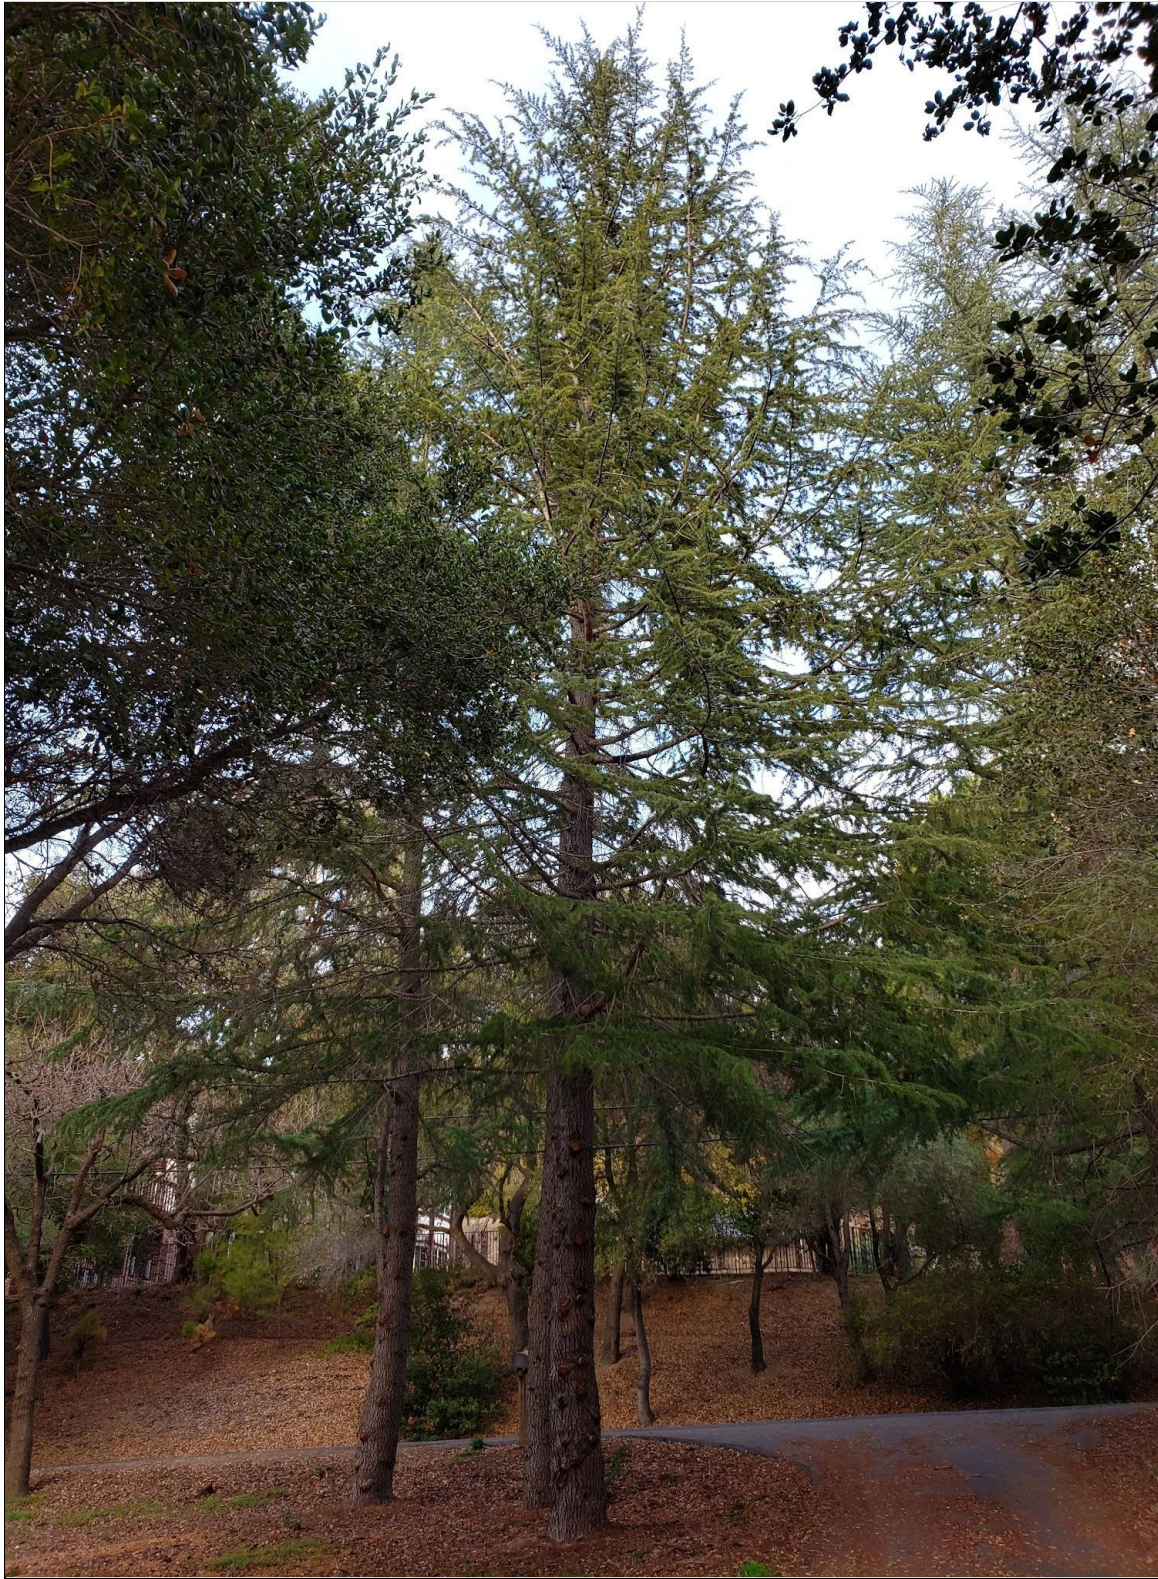
Image 4: deodar cedars #20-22

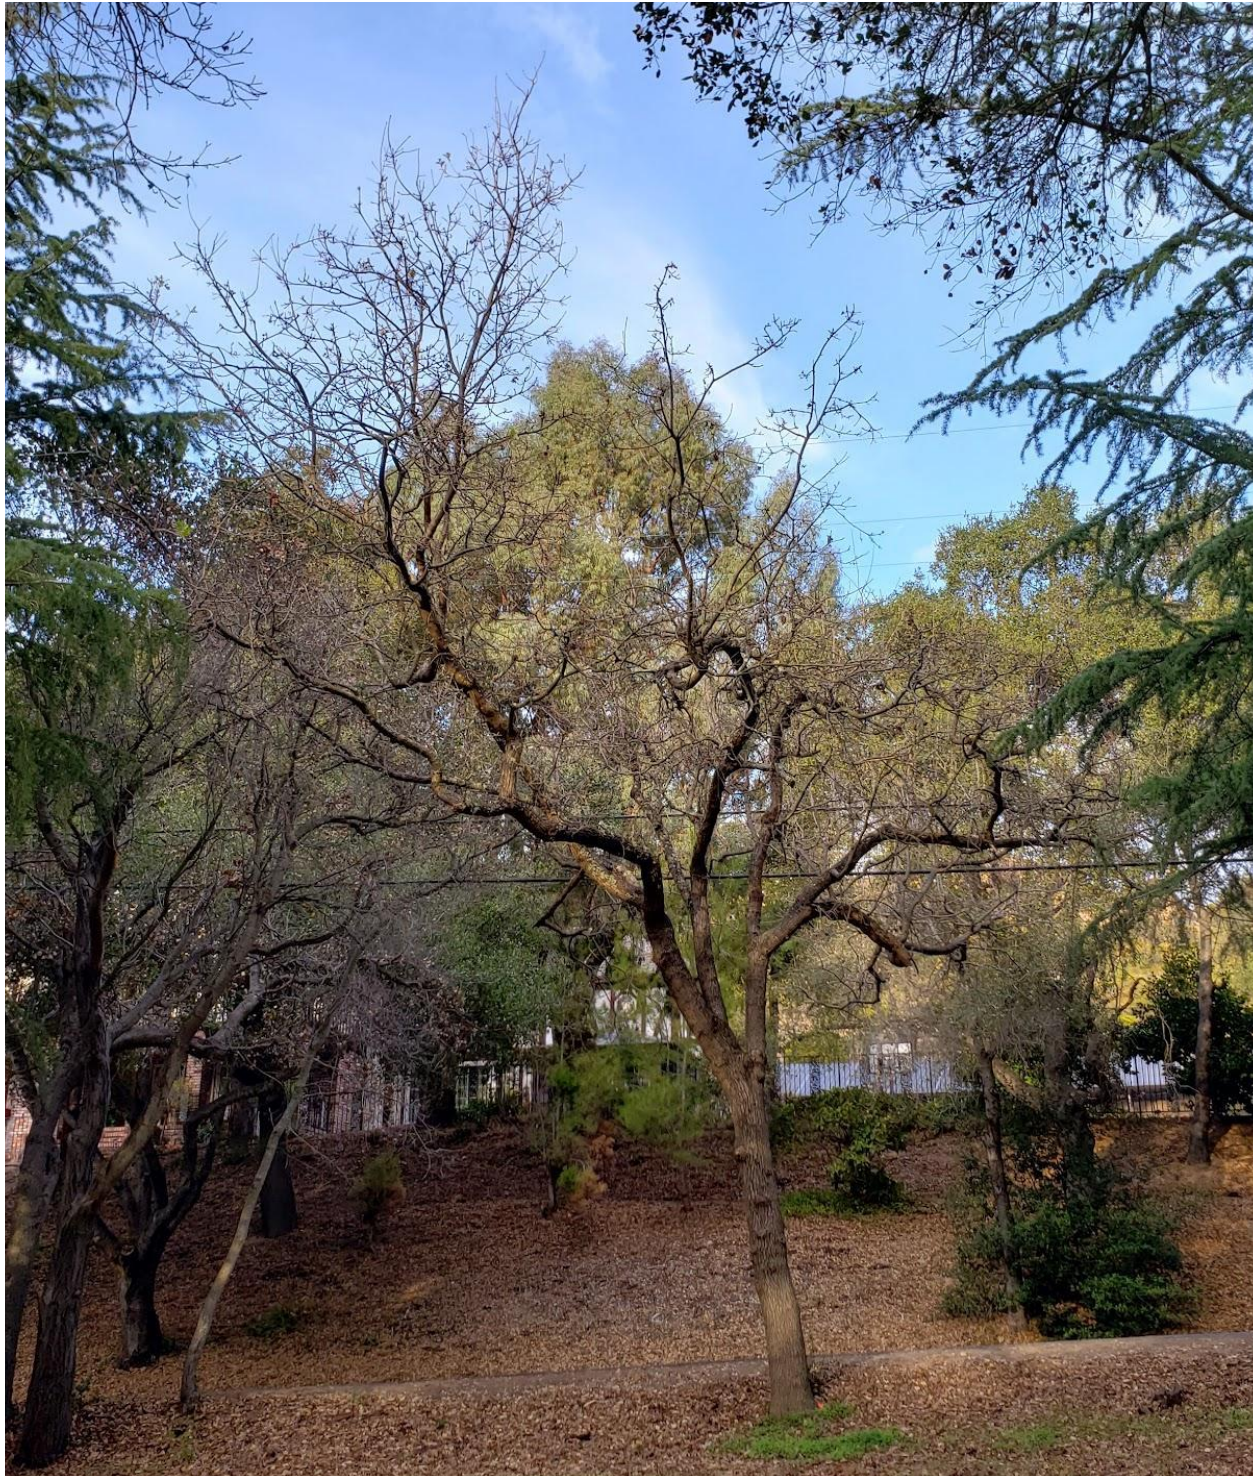
Image 5: valley oak #23

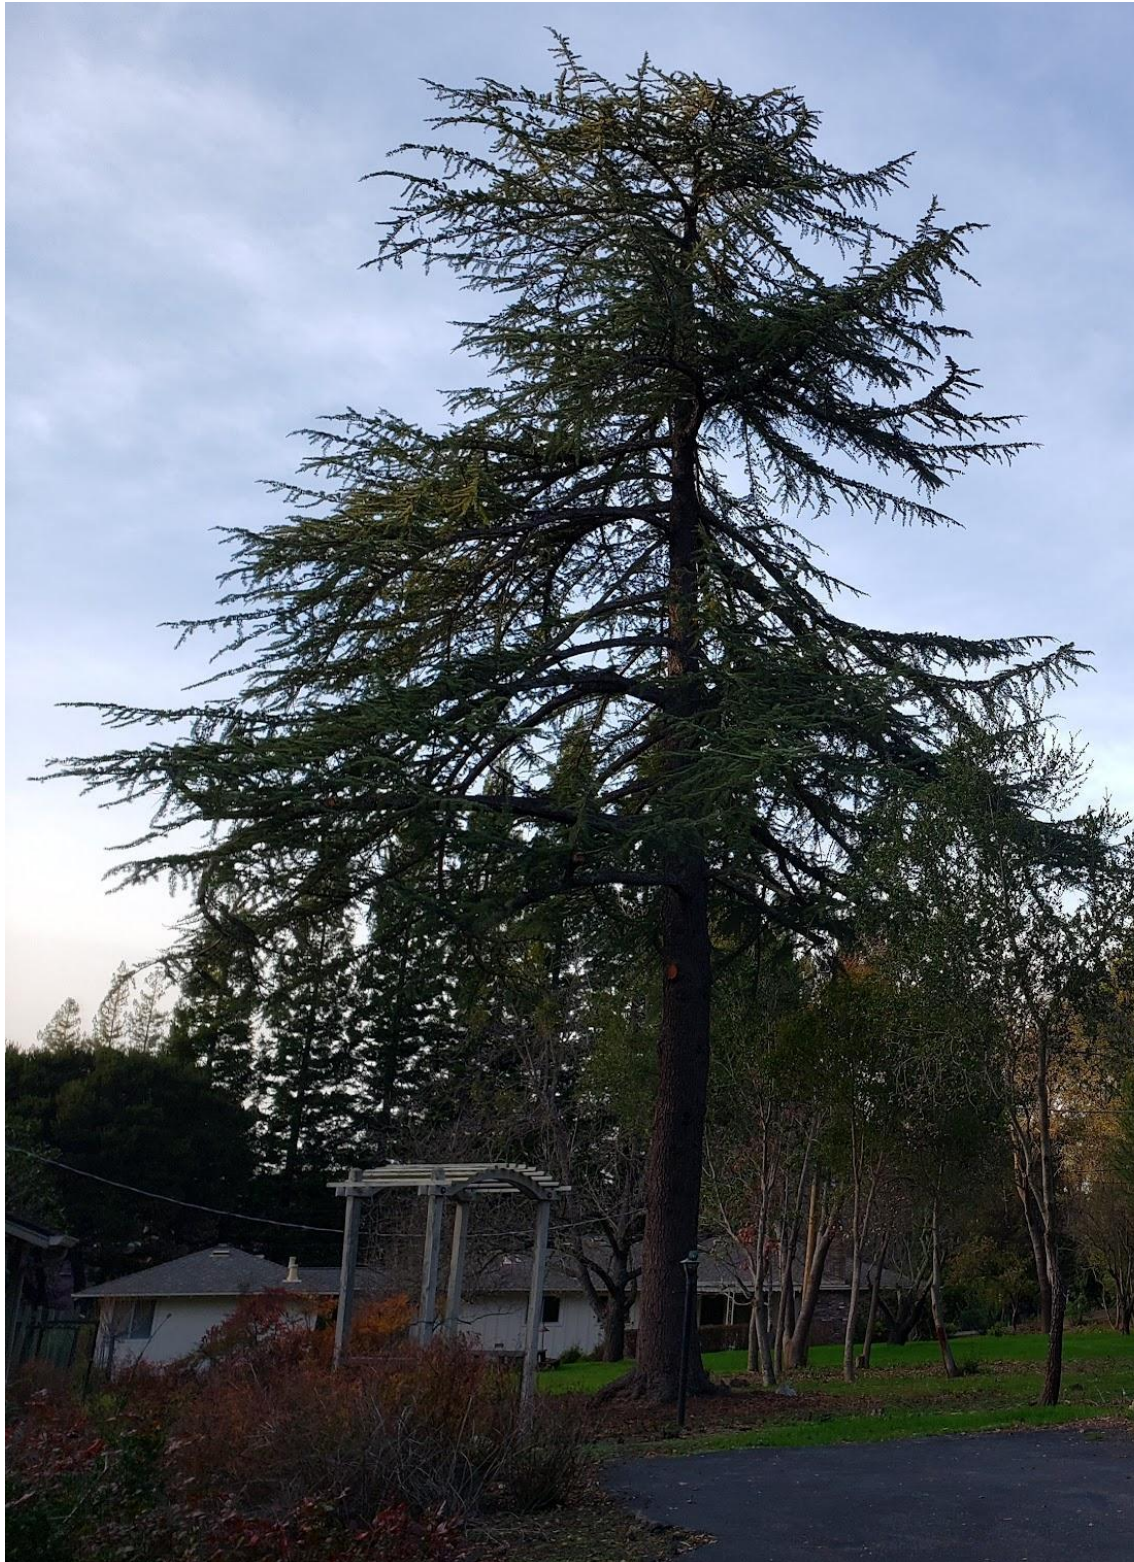
Tree #24 - several proposed features lie within this tree's TPZ: 1) the house; 2) the parking area; 3) the trash enclosure; 4) the gravel walkway above (northwest) of the house; 5) the vegetated swale.

These features all impact tree #24 to a minor degree, as does one of the vegetated swales. Taken together, impacts to this tree will likely be moderate.

Image 6: deodar cedar #24

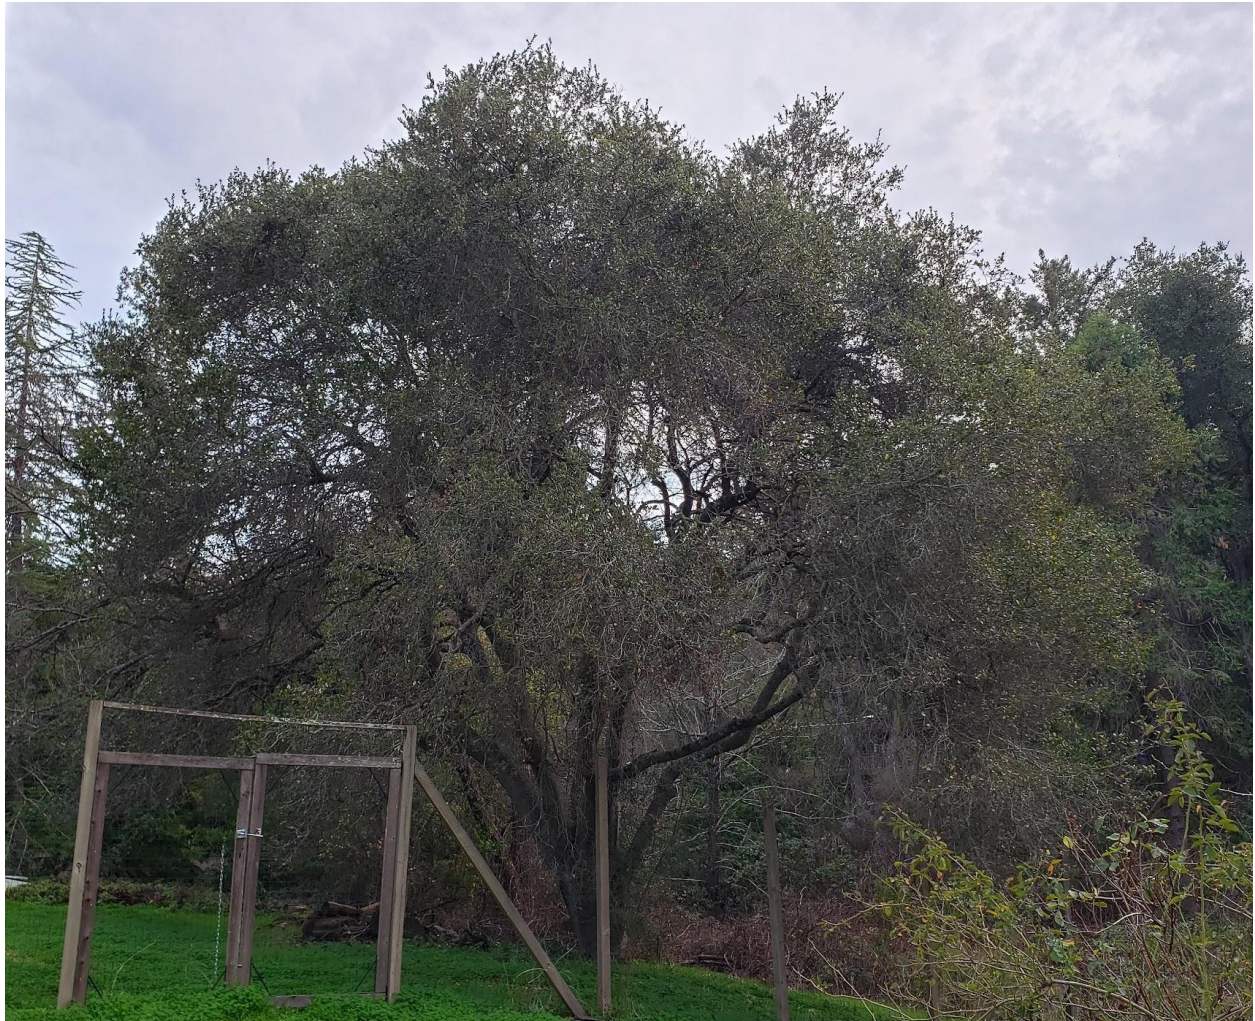
Tree #25 - several proposed features lie within this tree's TPZ: 1) the retaining wall for the pool patio; 2) the pool; 3) the vegetated swale

Tree #25 will likely undergo moderate impacts from the pool and patio.

Image 7: coast live oak #25

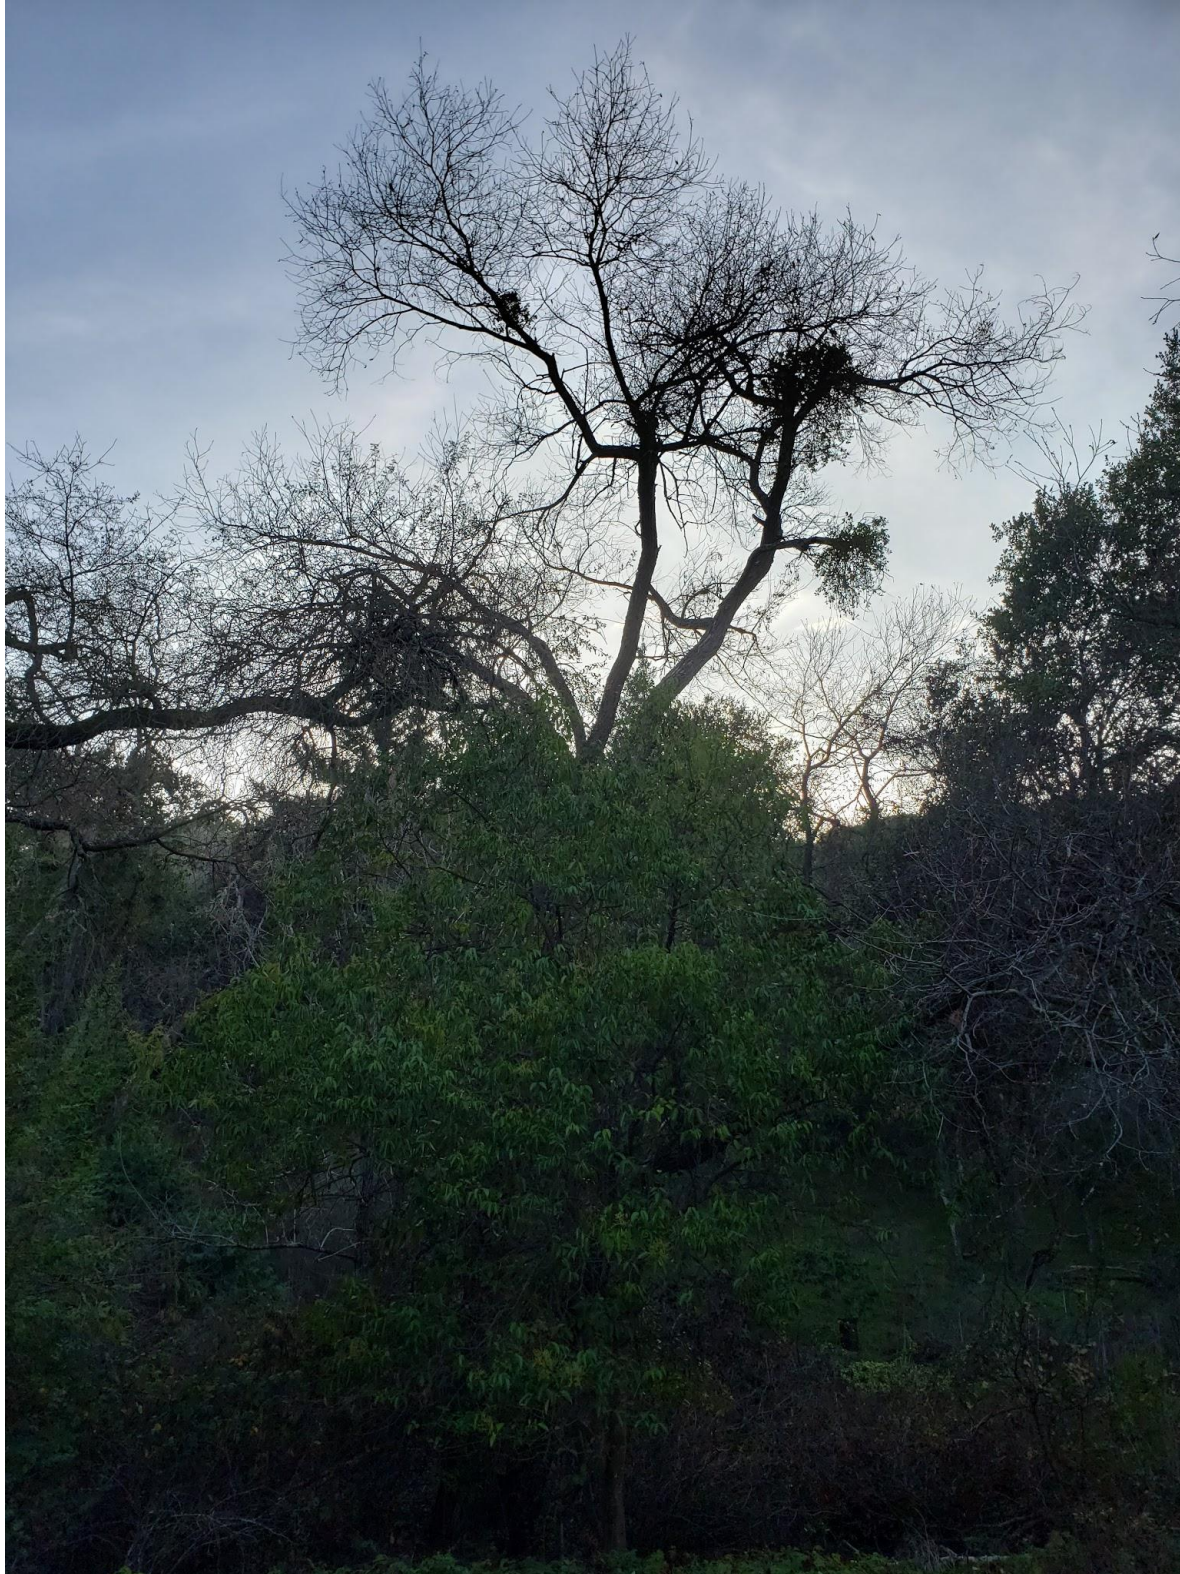
Tree #26 - this tree is located within the footprint of the proposed spa.

Tree #27 - this tree is located within the footprint of the proposed pool.

Trees #26 and 27 must be removed, as they are within the footprints of the pool and spa, respectively.

Image 8: privet #26 (small, foreground) and willow #27 (large, background)

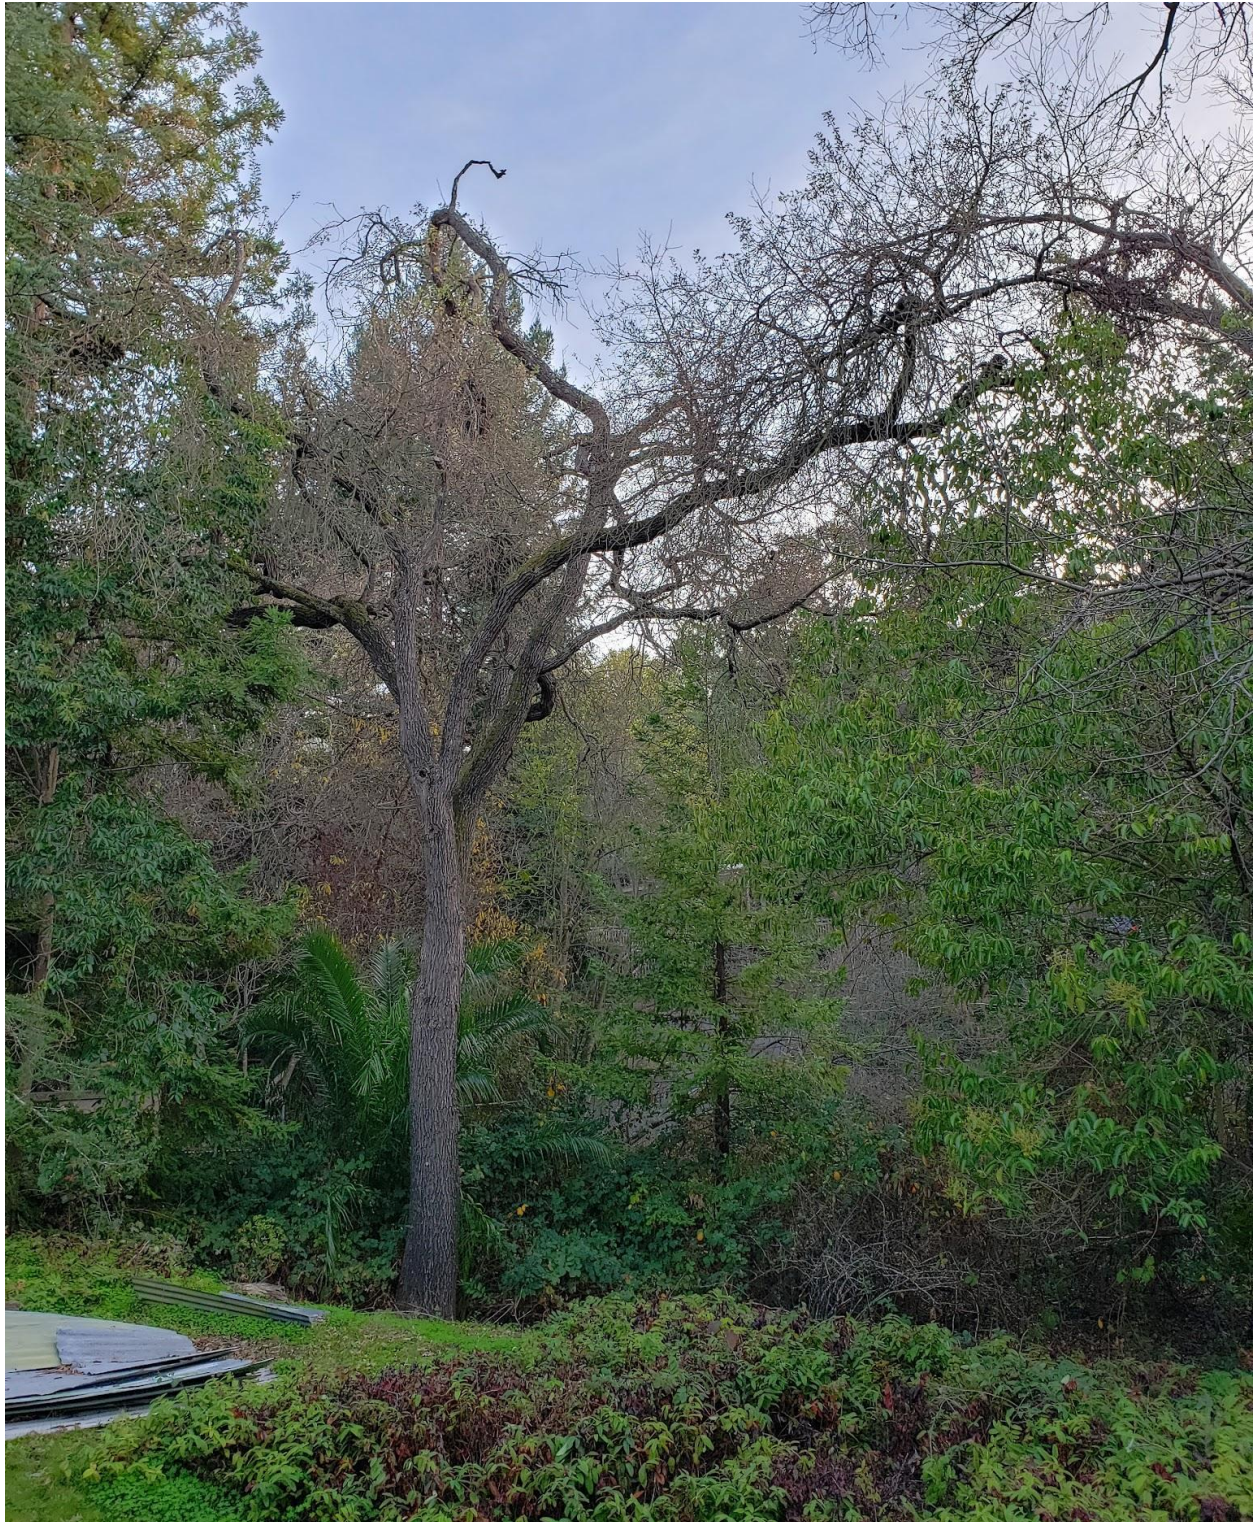
Tree #28 - the proposed pool and the retaining wall for the proposed pool patio lie within this tree's TPZ.

Tree #28 will likely undergo minor impacts from the pool, spa, and patio.

Image 9: valley oak #28

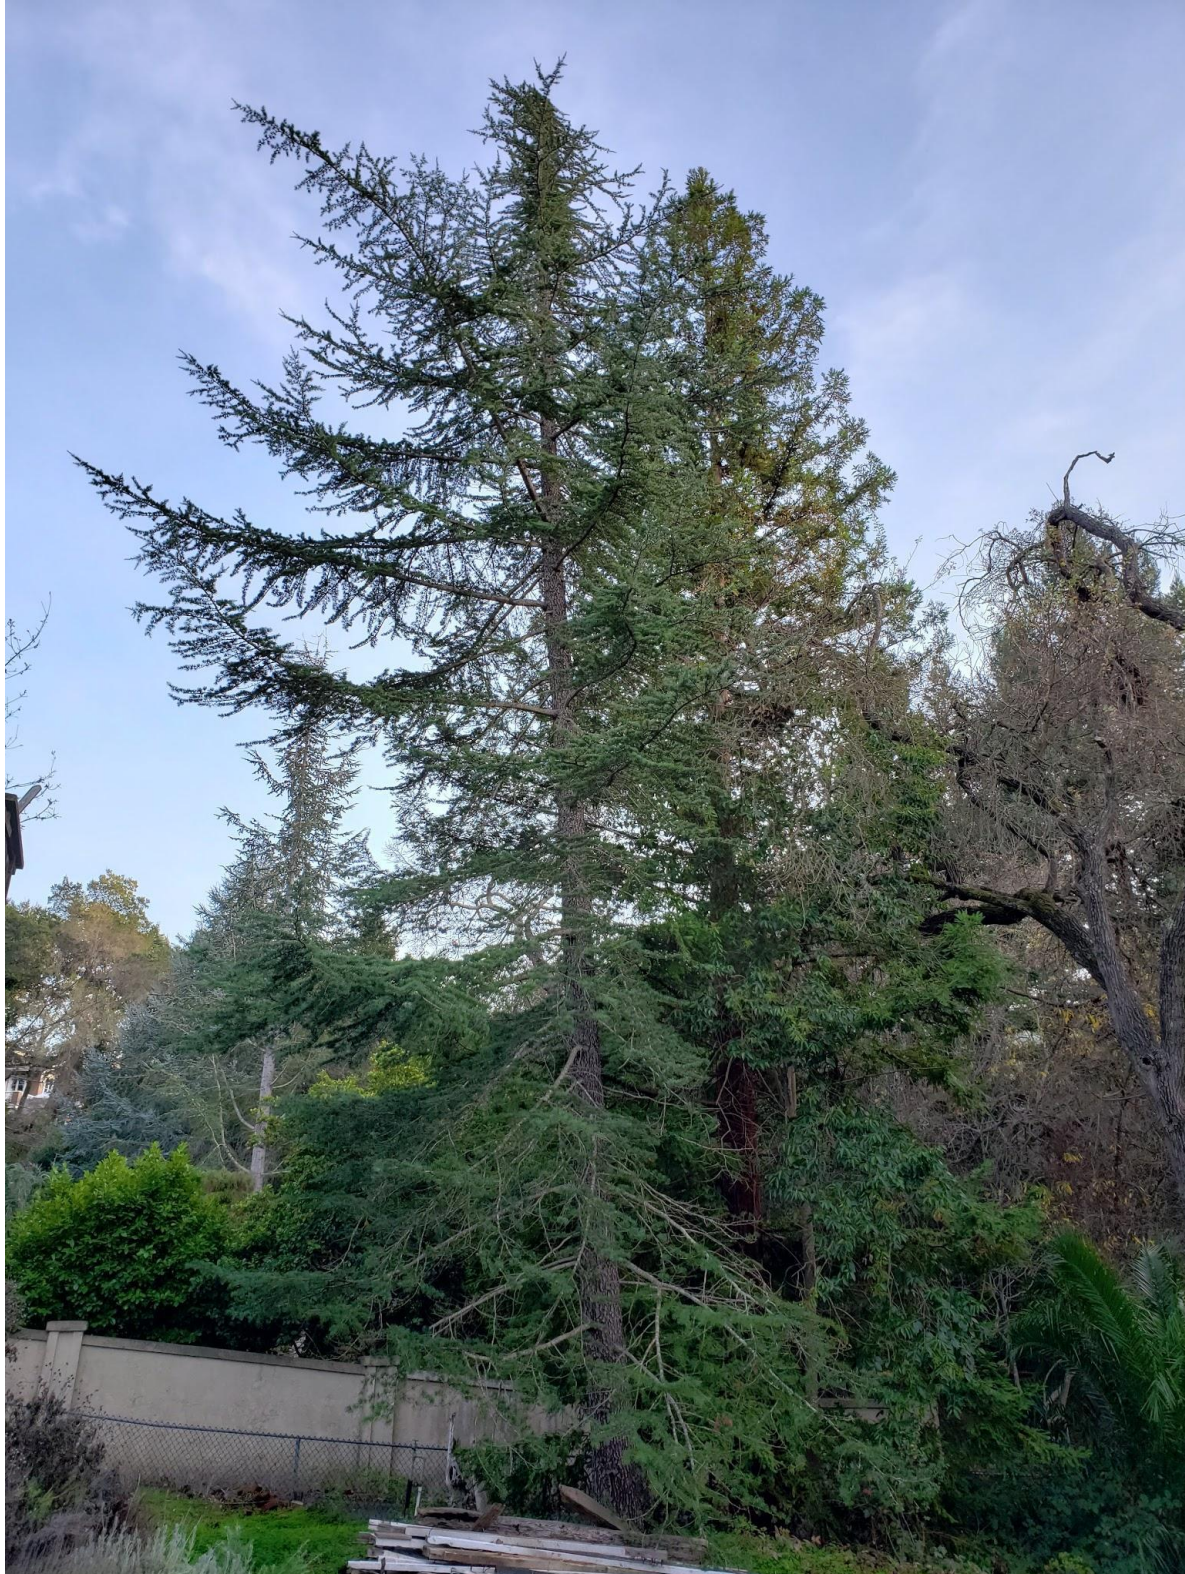
Tree #29 - construction access for the retaining wall for the proposed artificial turf area lies within this tree's TPZ.

Tree #32 - the vegetated swale lies within this tree's TPZ.

Construction access for the retaining wall will likely cause minor impacts to tree #29.

Image 10: deodar cedar #29 (foreground) and redwood #32 (background, obstructed)

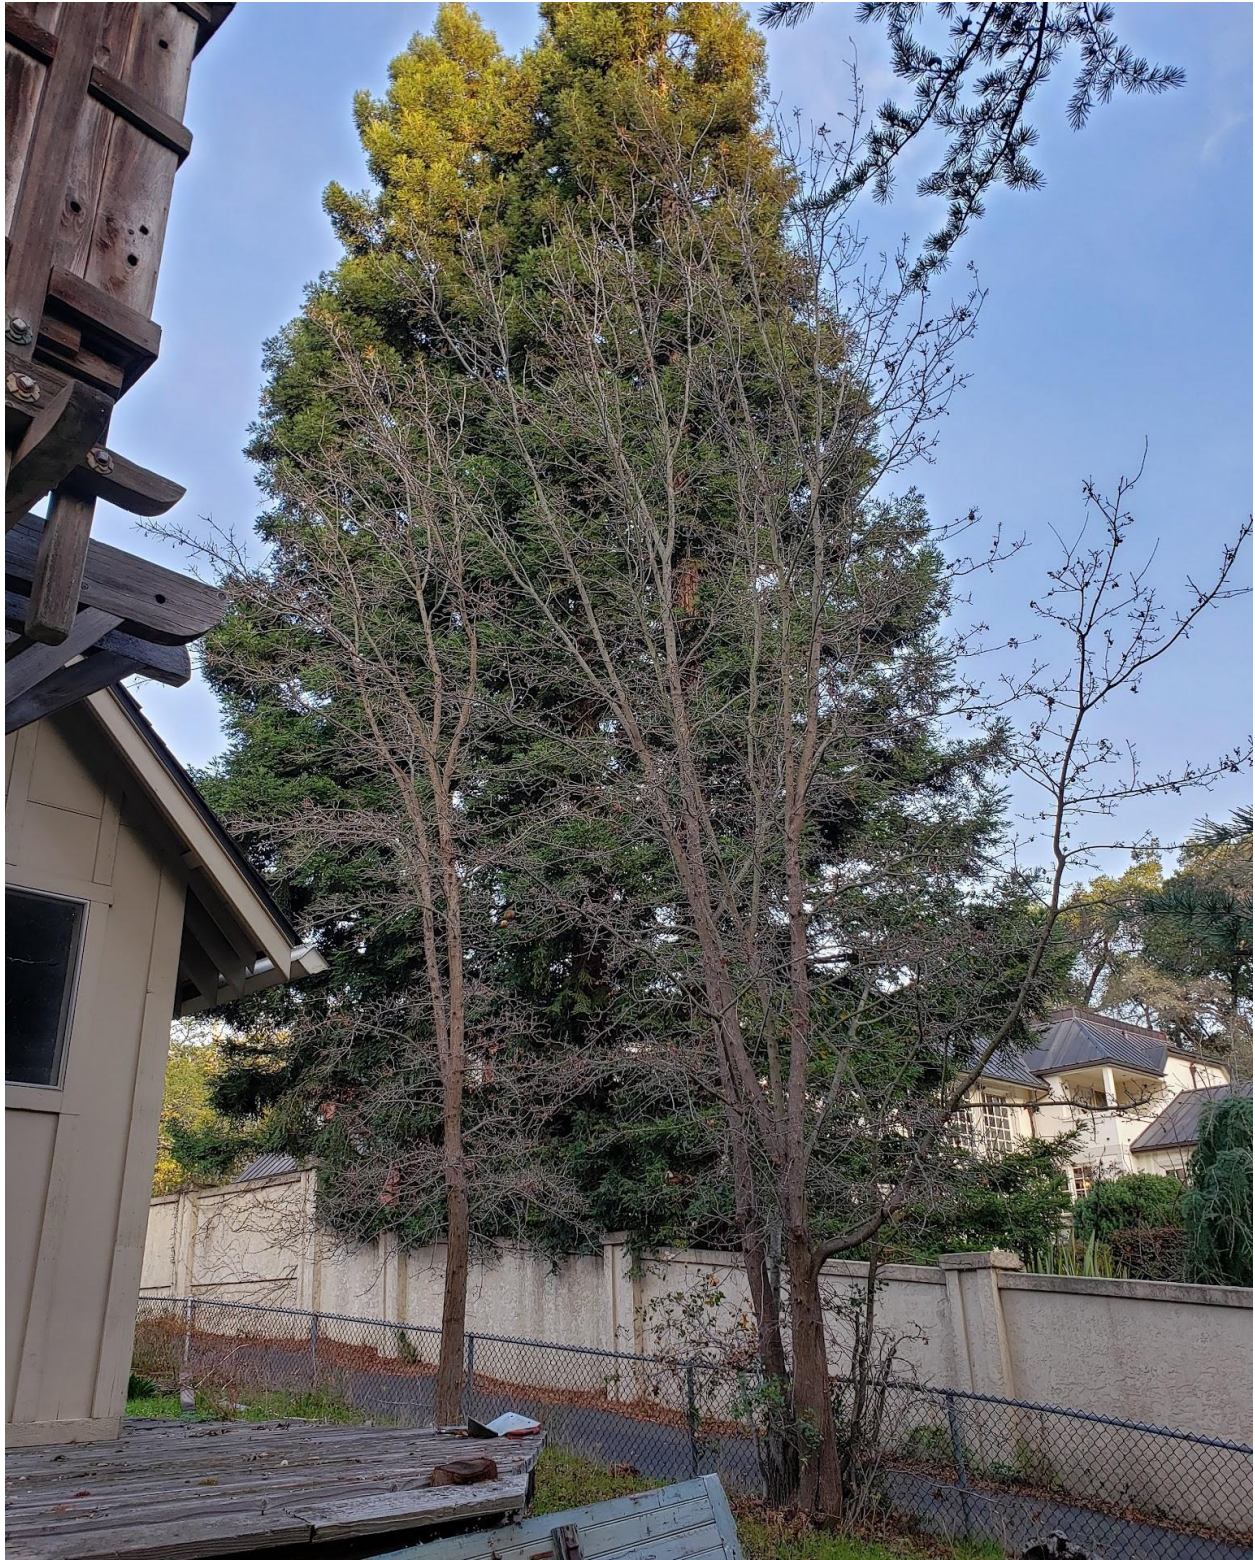
Trees #30 and 31 - these trees lie within the footprint of the proposed artificial turf area.

Trees #30 and 31 will need to be removed for this feature to be installed.

Image 11: valley oaks #30 (left) and 31
